Maribyrnong Flood Event October 2022- Post Event Analysis

Document no: Jacobs Group (Australia) Pty Ltd
Revision no: FINAL- For Information Only

Melbourne Water

28 March 2023

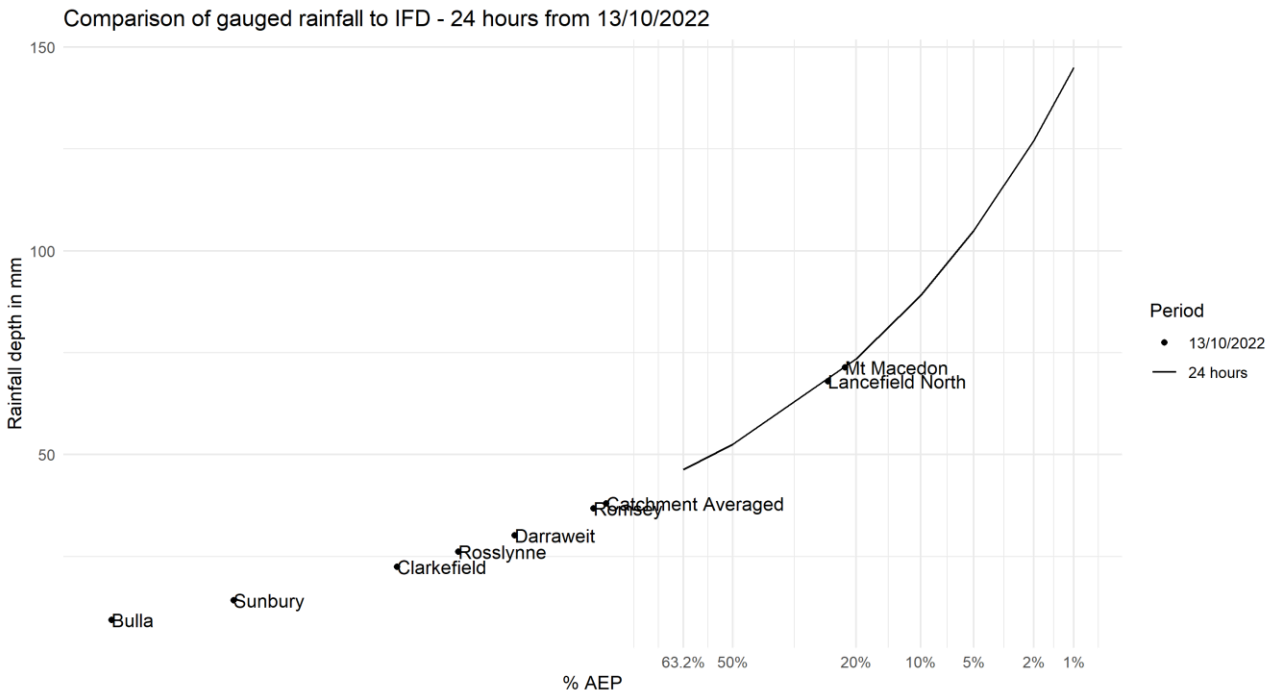
Figure 3: Comparison of rainfall to 9:00am on the 13/10/2022 to catchment centroid IFD

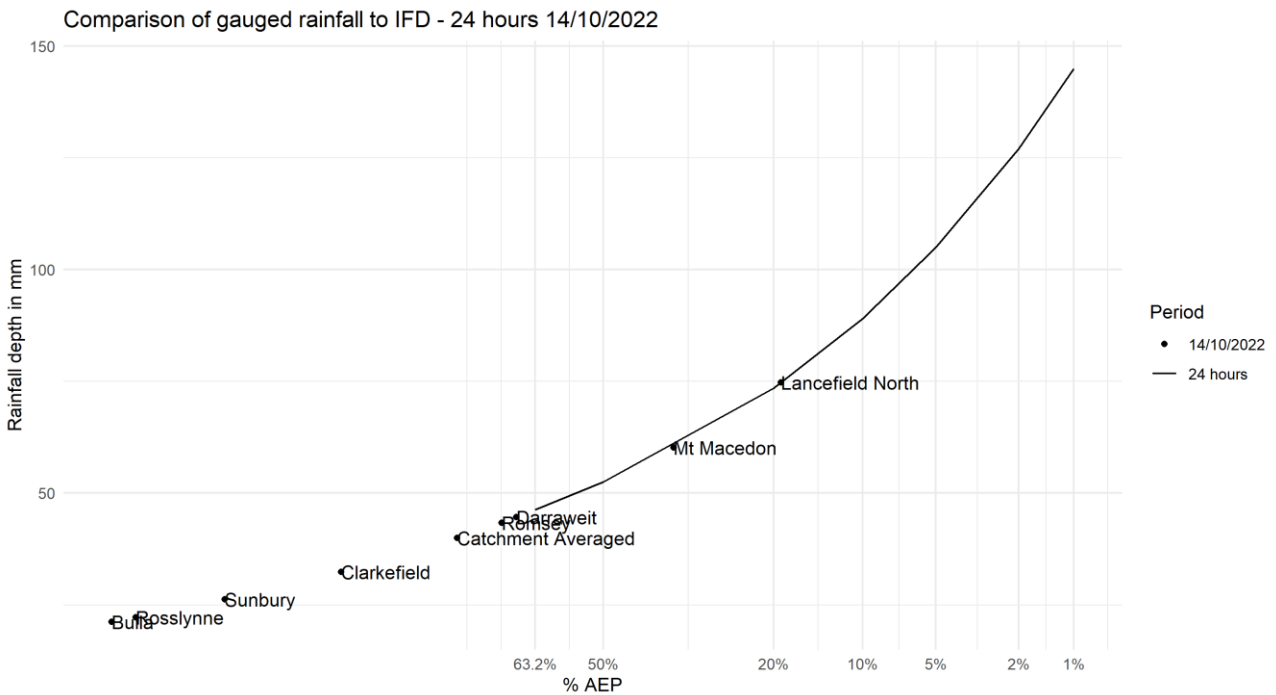
Figure 4: Comparison of rainfall to 9:00am on the 14/10/2022 to catchment centroid IFD

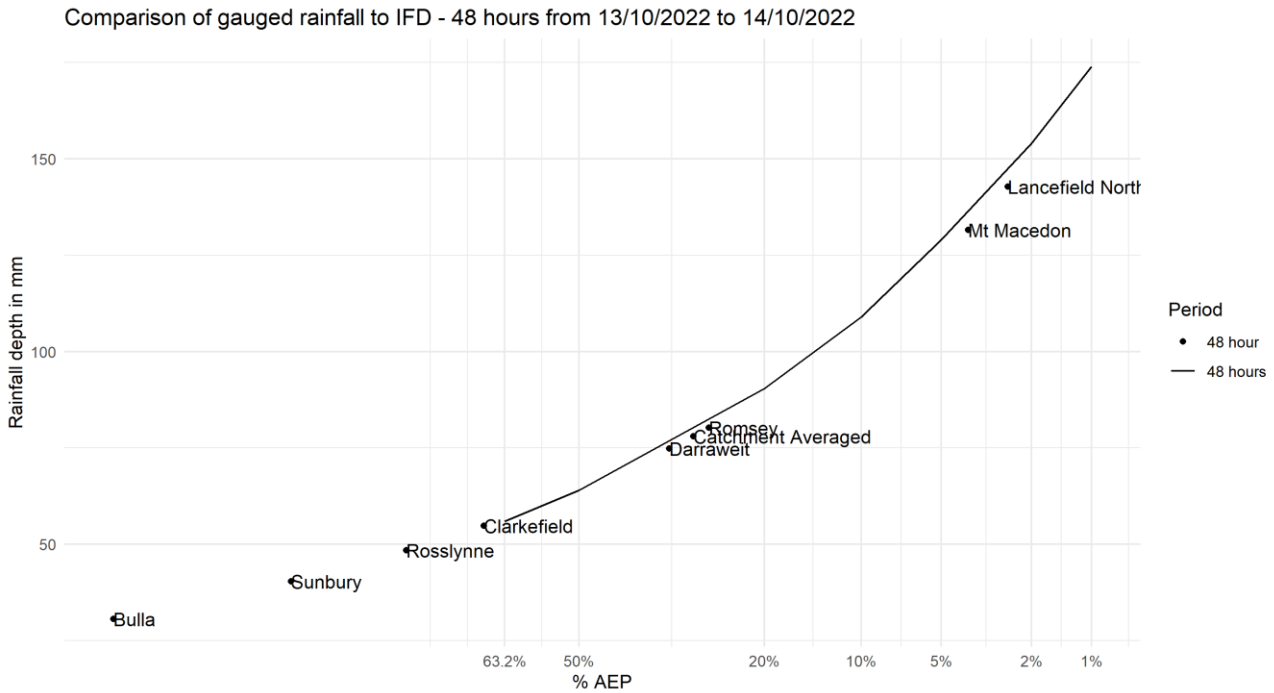
Figure 5: Comparison of 48 rainfall on the 13/10/2022 and 14/10/2022 to catchment centroid IFD

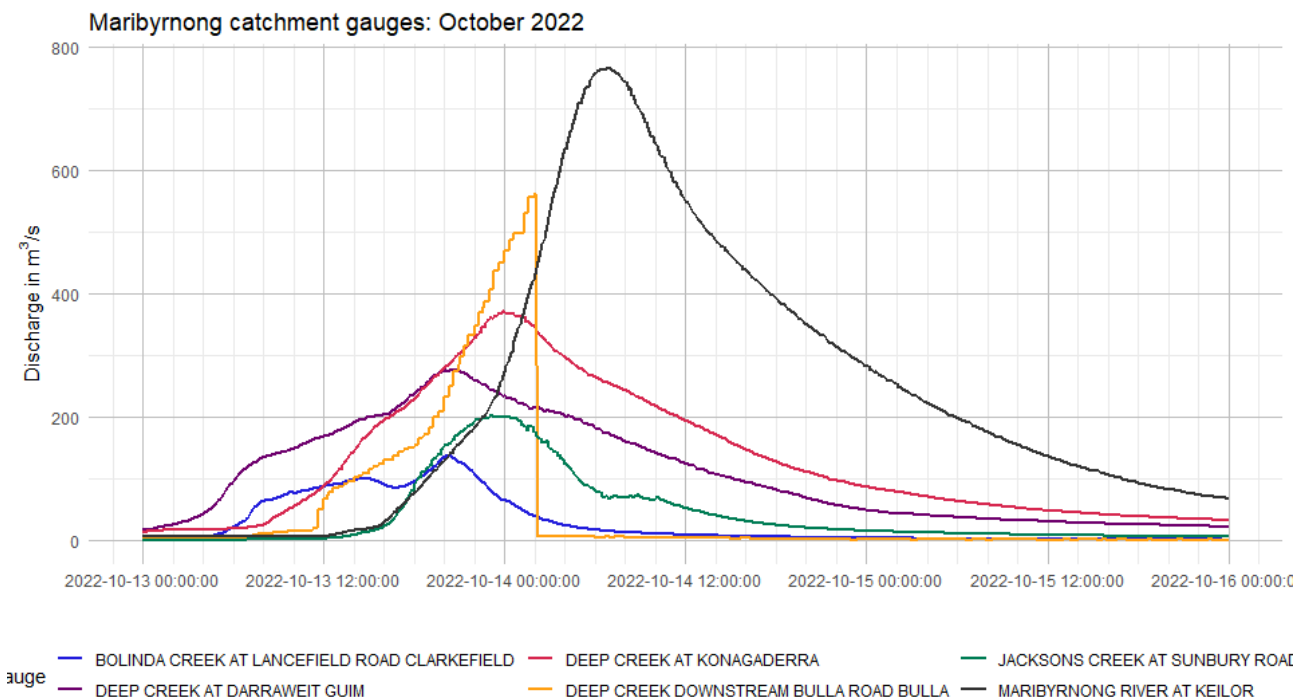
Figure 12: Hydrographs for various gauges in the Maribyrnong catchment for the October 2022 event

Review of the information in Table 5, Figure 12 and Figure 13 shows that:

- There was a large flow event in the Deep Creek catchment.
- The Jacksons Creek catchments provided the next largest input in terms of flow.
- Although the Bolinda Creek / Emu Creek is only (approximately) 55% the size of the Jacksons Creek catchment, it provided a similar input in terms of flow.
- The gauge at Deep Creek Downstream Bulla Road Bulla is understood to have recorded the peak flow correctly, before failing and becoming inaccurate shortly afterwards, as is evident from the drop data values in Figure 12.

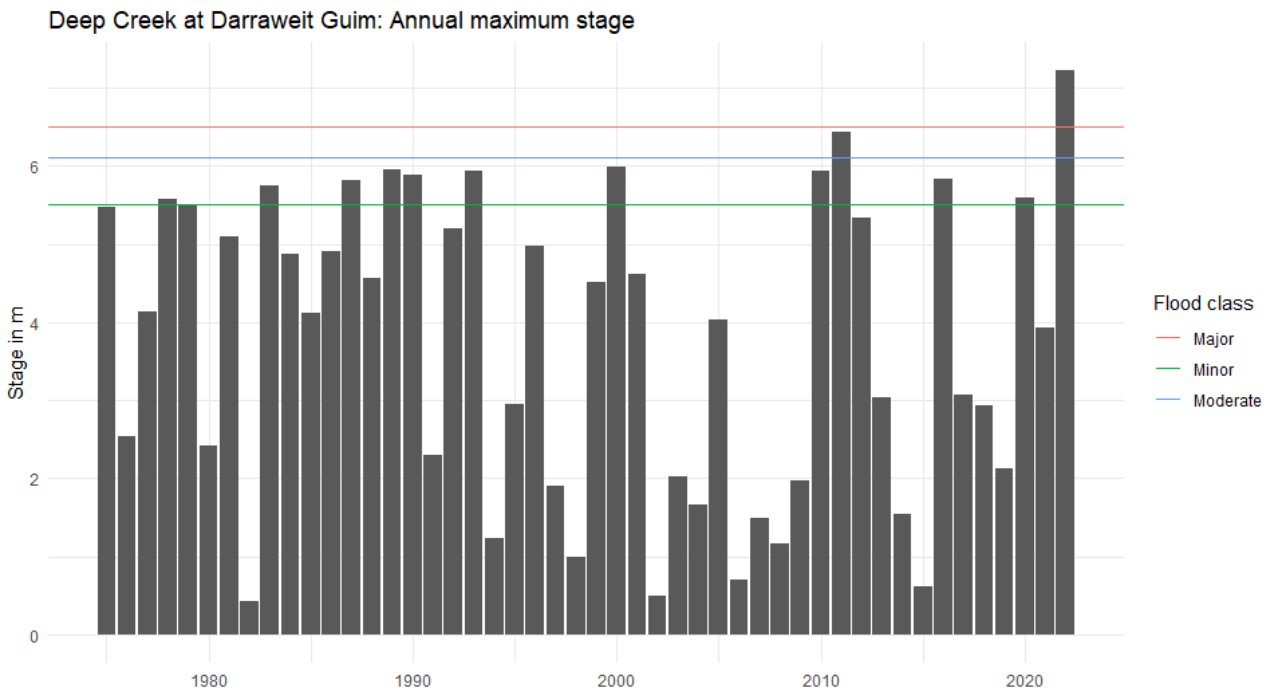
Figure 14: Deep Creek at Darraweit Guim – annual maximum stage data (1975 – 2022) (The Bureau⁵, 2022)

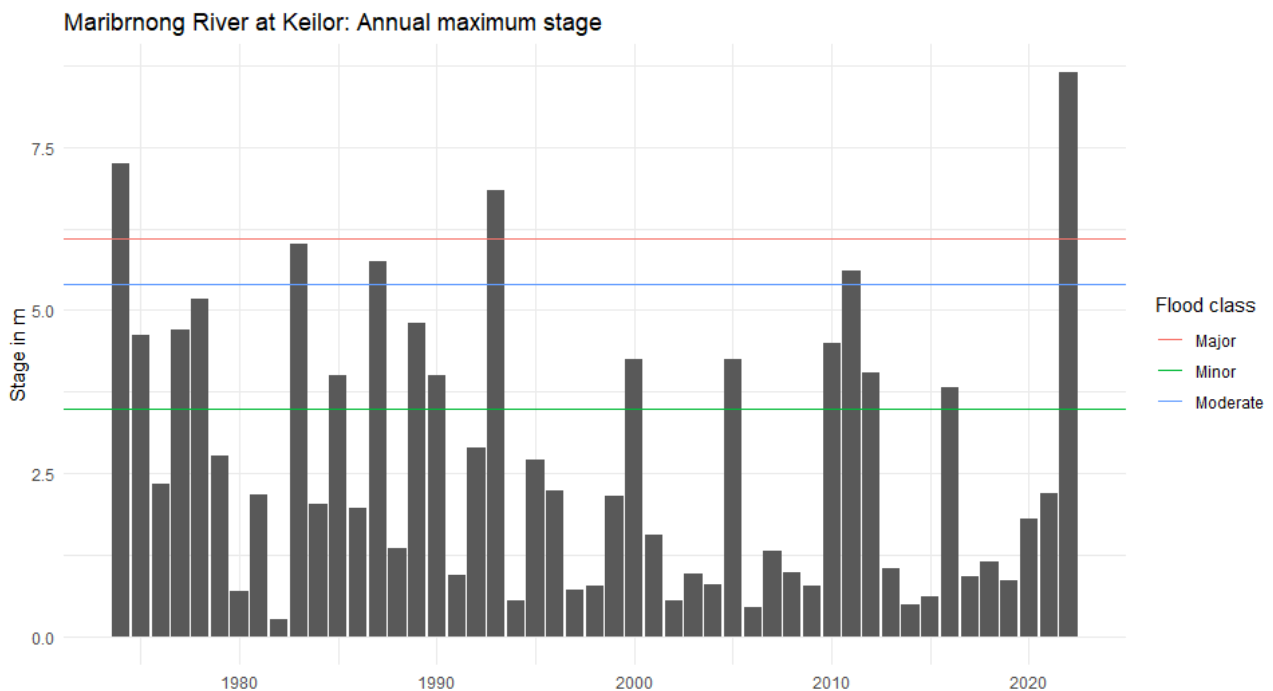
Figure 15: Maribrnong River at Keilor – annual maximum stage data (1974 – 2022) (DEWLP²⁵, 2022)

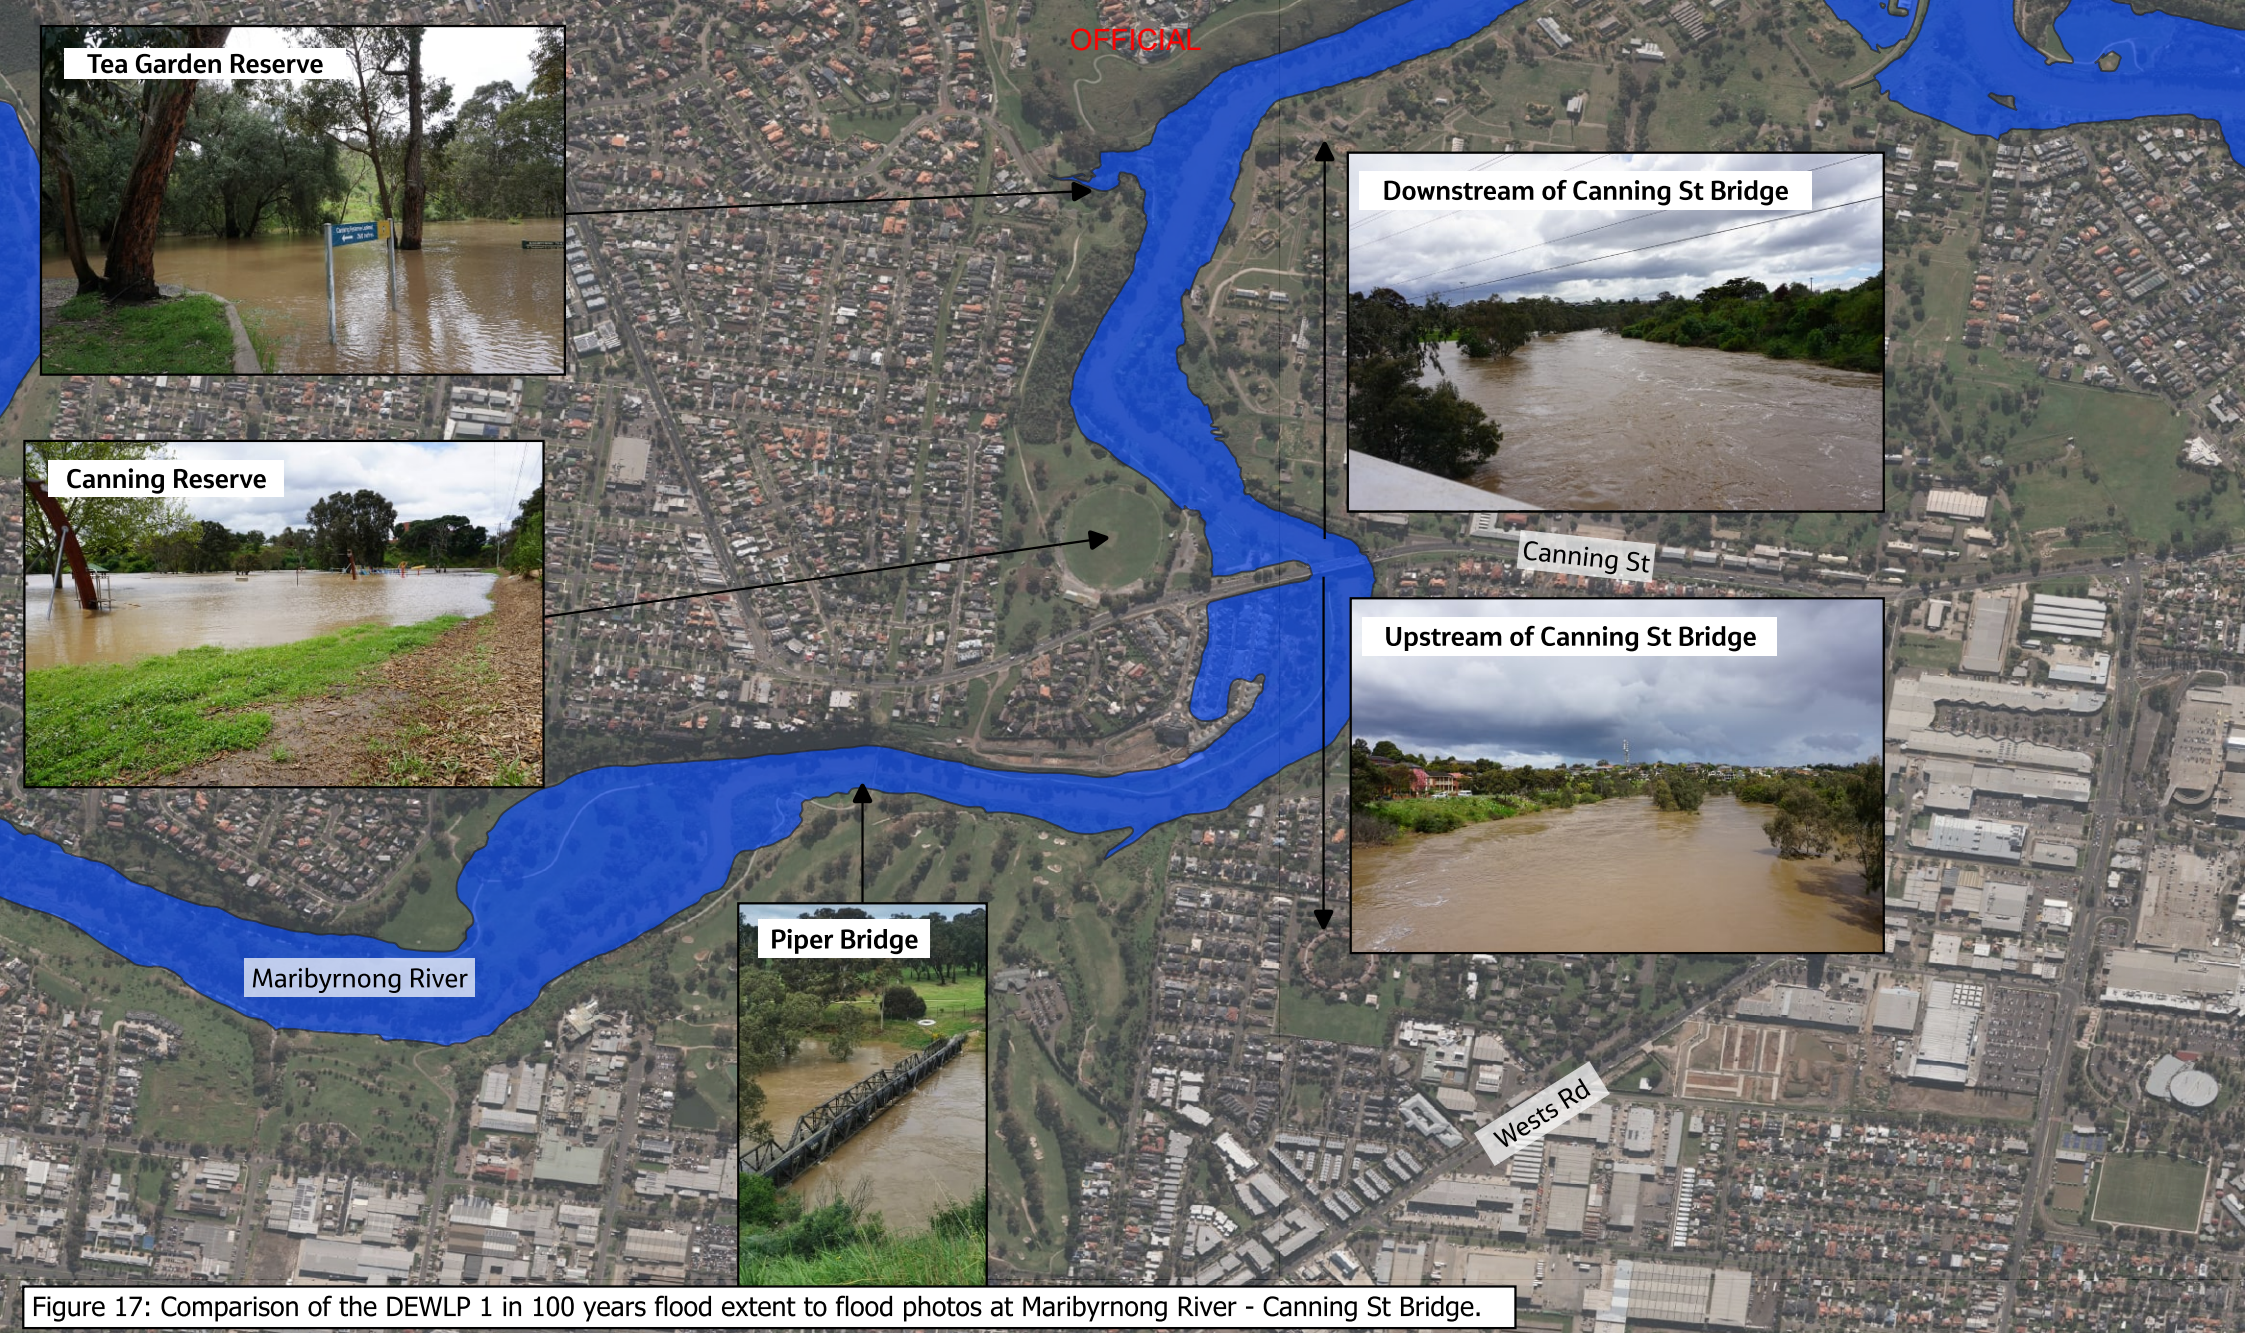
Figure 17: Comparison of the DEWLP 1 in 100 years flood extent to flood photos at Maribyrnong River - Canning St Bridge.

- Upstream of Canning Street Bridge – the 1% AEP extent was consistent with the observed flooding although it is noted that it was difficult to be precise with available data.

- The 1% AEP extent shows inundation in and around Blueridge Close and Evergreen Avenue in Figure 17. It was observed that this area had been flooded and did not appear to be as extensive as the flood mapping indicated, although a full inspection of the area was not undertaken.

- Downstream of Canning Street Bridge - the 1% AEP extent was consistent with the observed flooding although it is noted that it was difficult to be precise with available data.

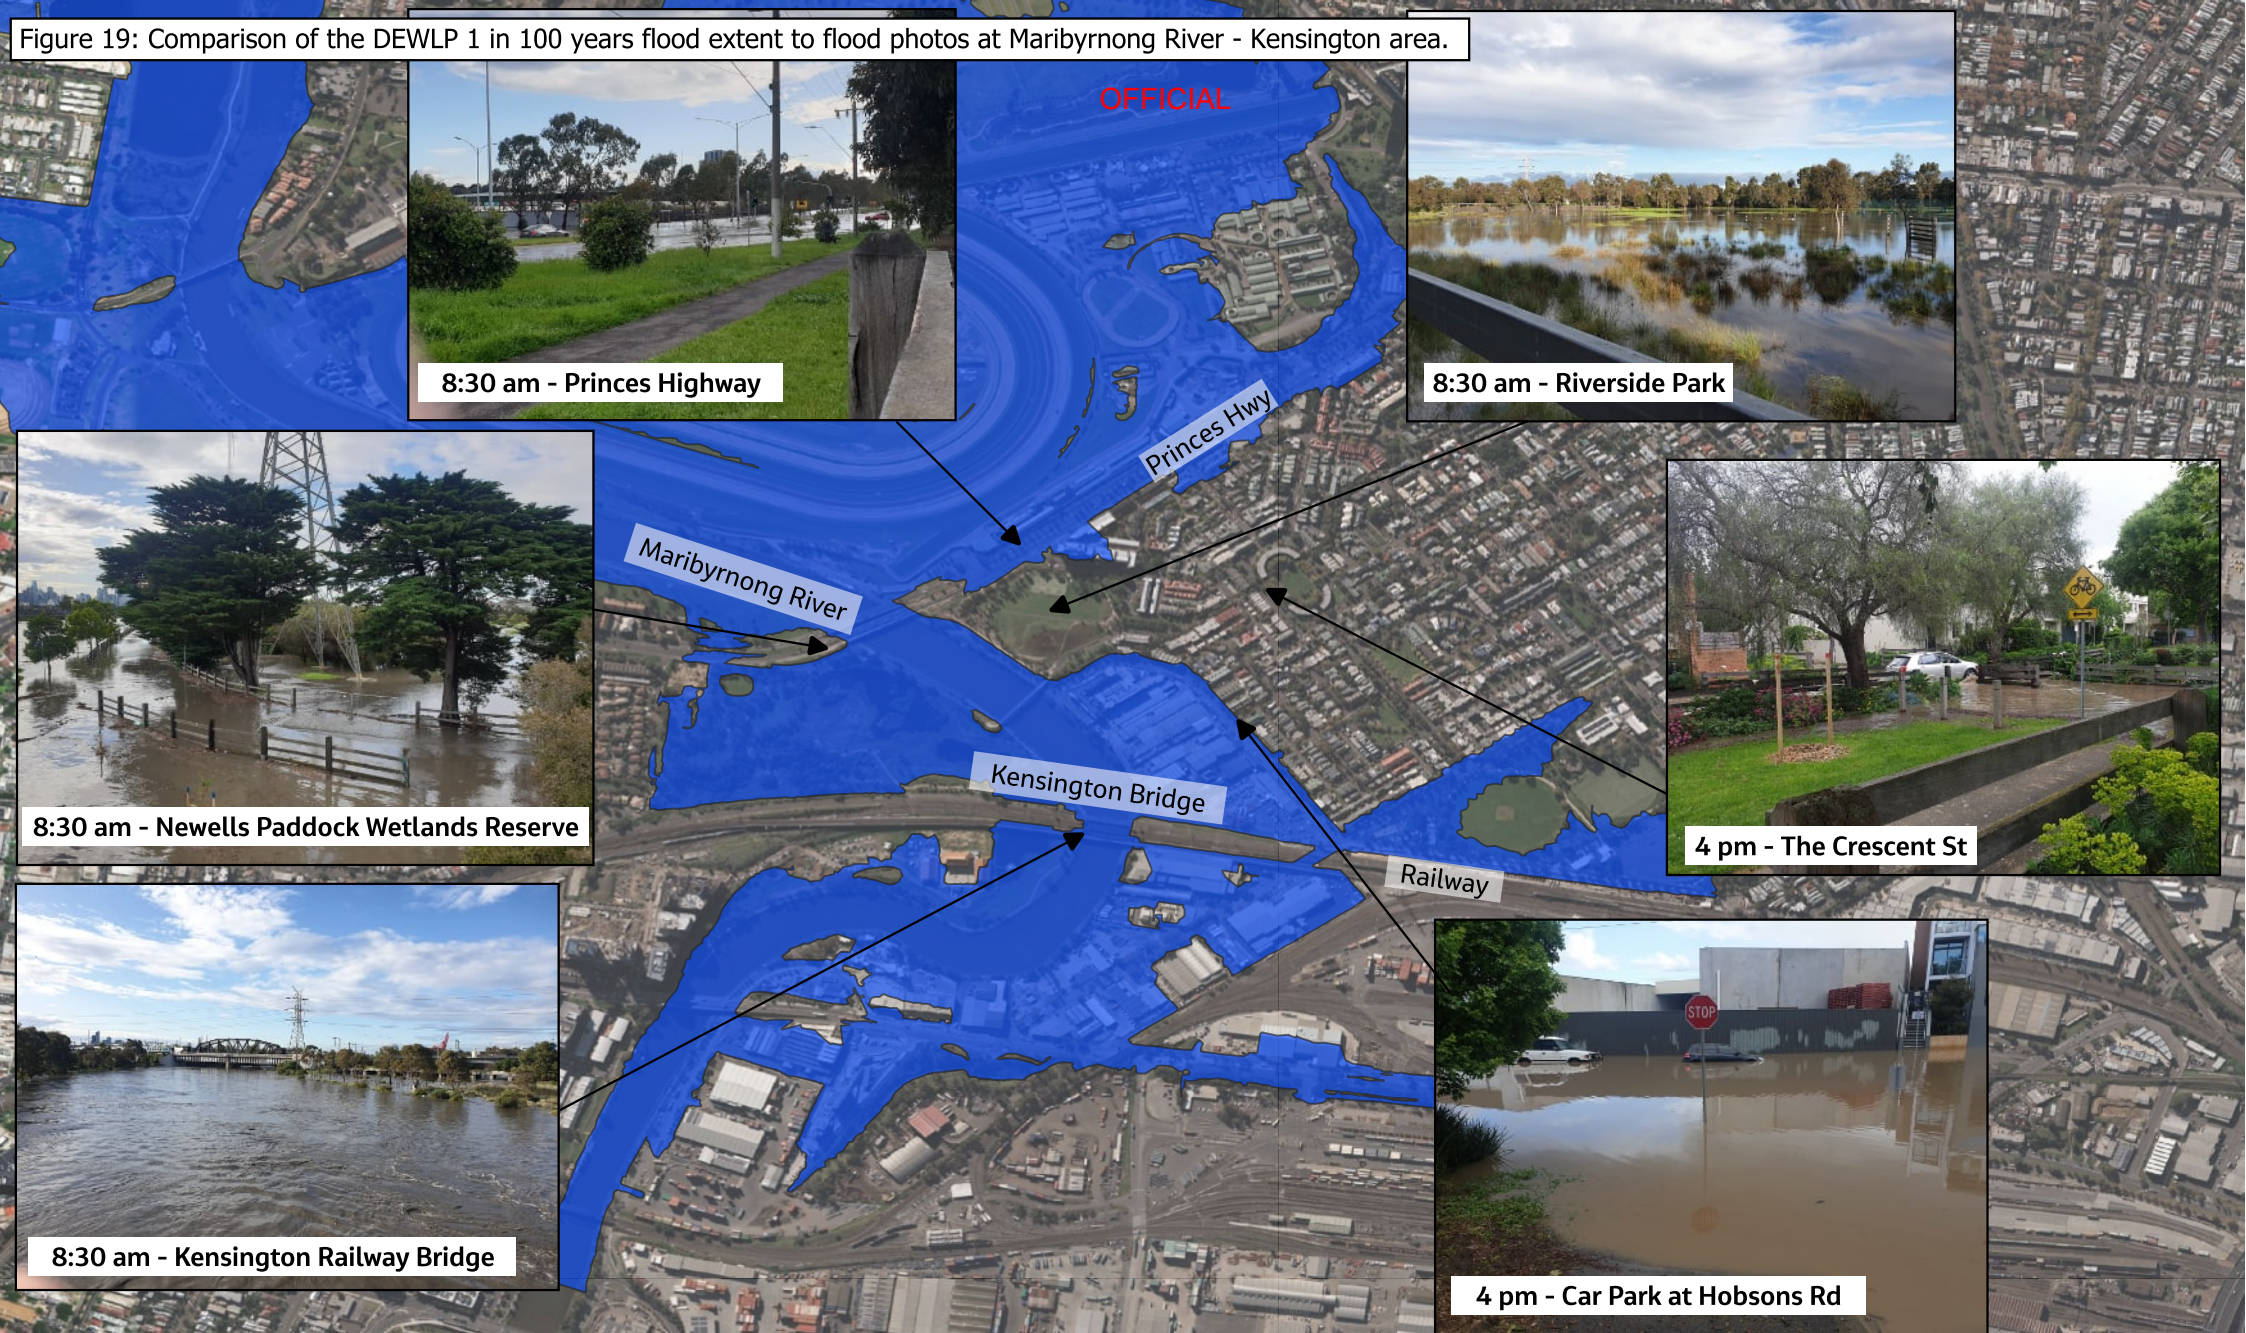
Figure 19: Comparison of the DEWLP 1 in 100 years flood extent to flood photos at Maribyrnong River - Kensington area.

- Riverside Park – the 1% AEP extent is inconsistent with the observed flooding that occurred. Photos taken show widespread inundation at Riverside Park, whereas the park is dry in the DELWP 1% AEP extent.

- Crescent Street – the 1% AEP extent is inconsistent with the observed flooding that occurred. Photos taken show inundation of Crescent Street, whereas this area is dry in the DELWP 1% AEP extent. This is likely due to underground drainage not being used in the modelling that the DELWP 1% AEP extent was derived from.

- Hobsons Road – Photos taken from Bateman Road looking on to Hobsons Road are generally in agreement with the 1% AEP flood extents (noting that photos were taken slightly after the peak).

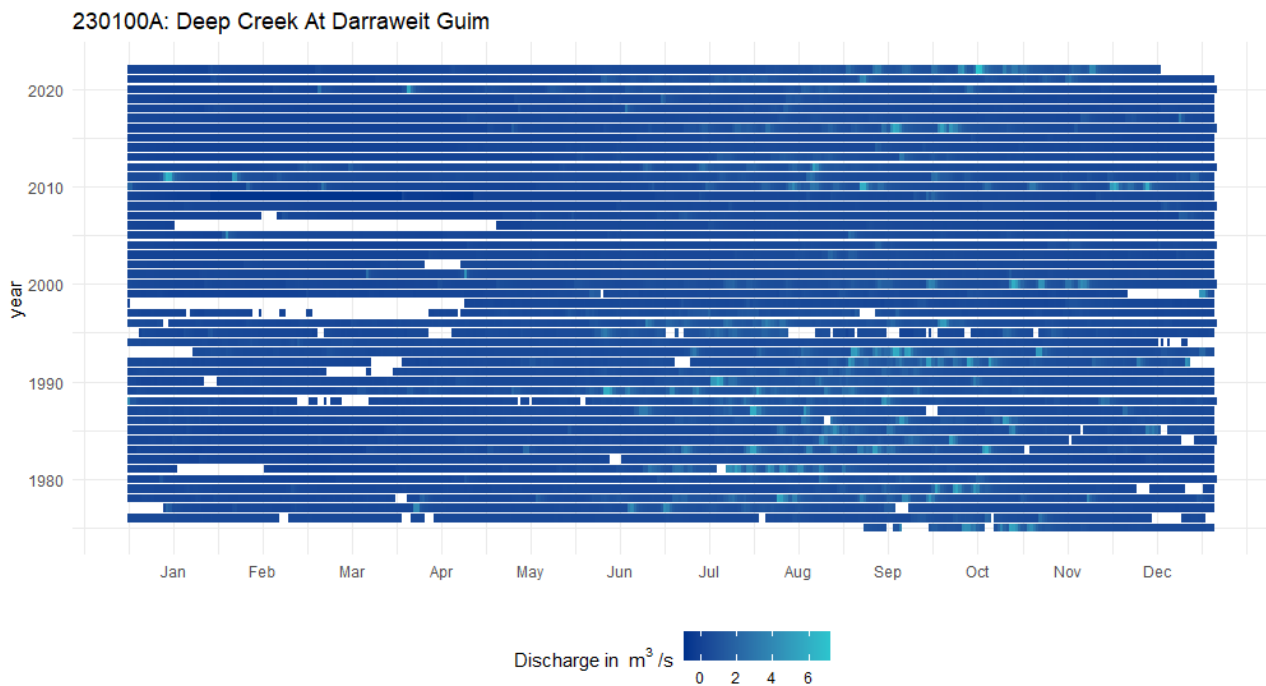
Figure 20: Available data for Deep Creek at Darraweit Guim (230100A)

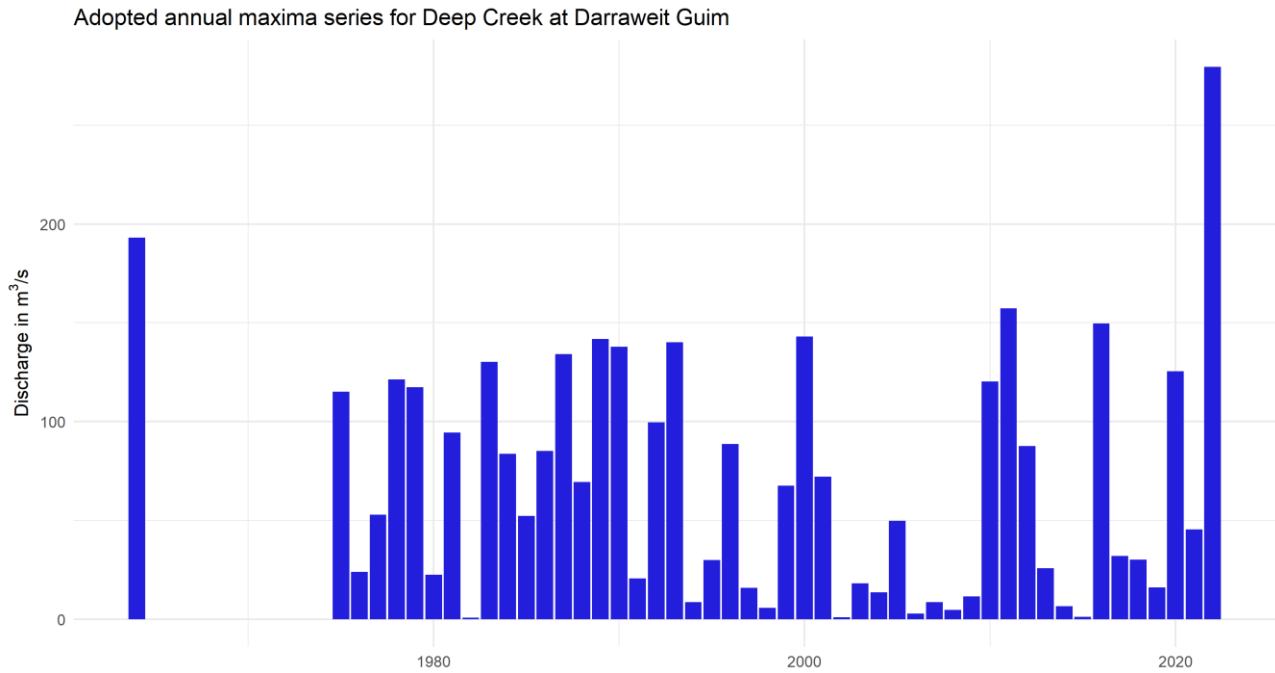
Figure 21: Deep Creek at Darraweit Guim adopted annual maxima series

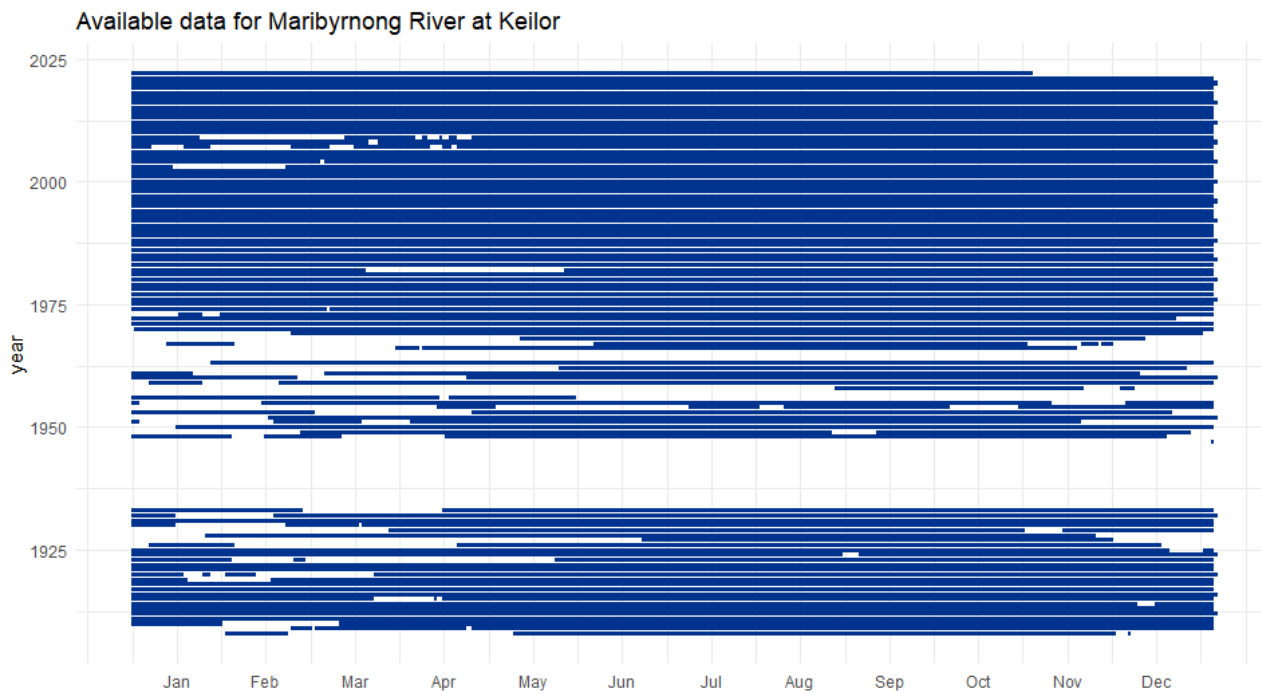
Figure 22: Available data plot Maribyrnong River at Keilor

Review of this gauge found that there were 27 years of missing annual maxima data due to missing years or gaps in the continuous flow record. Data from either MMBW or the Bureau's records were adopted in some instances (5 years) where uncertainty around DEWLP's records was present due to missing data.

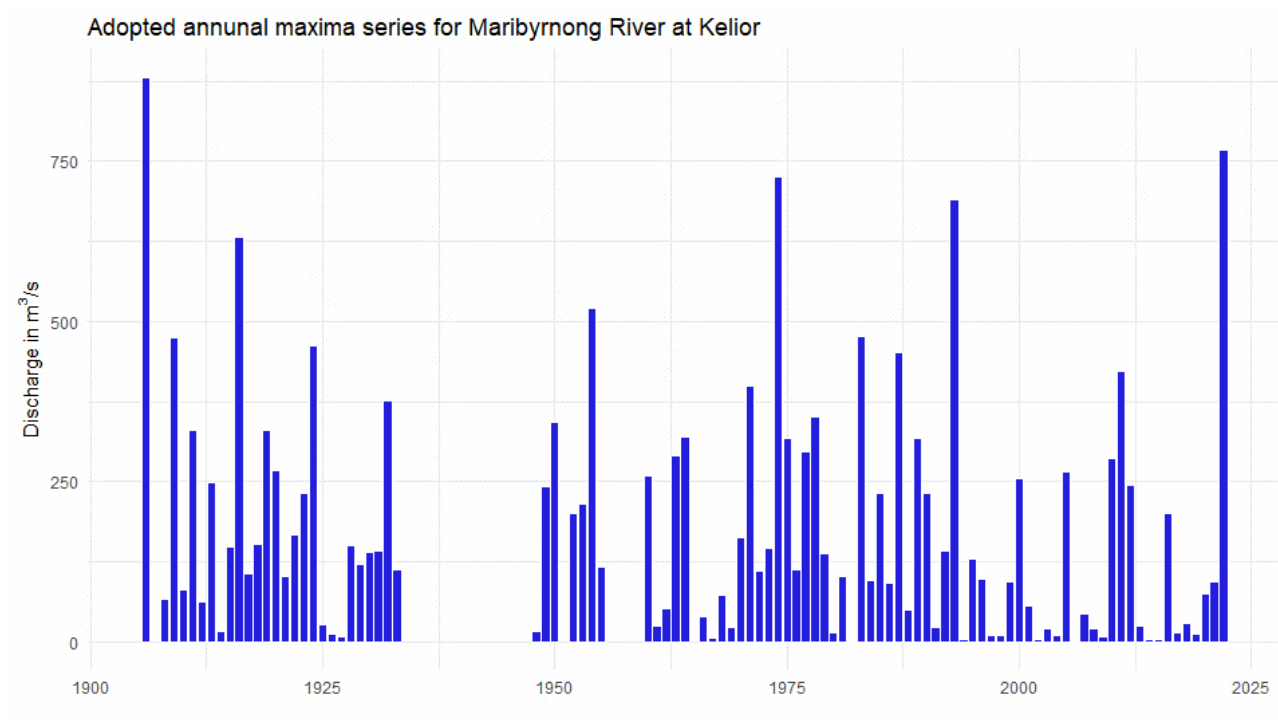
Figure 23: Maribyrnong River at Keilor adopted annual maxima series

The adopted annual maxima series consists of 90 years from 1906 to 2022 as presented in Figure 23 and listed in Table 11.

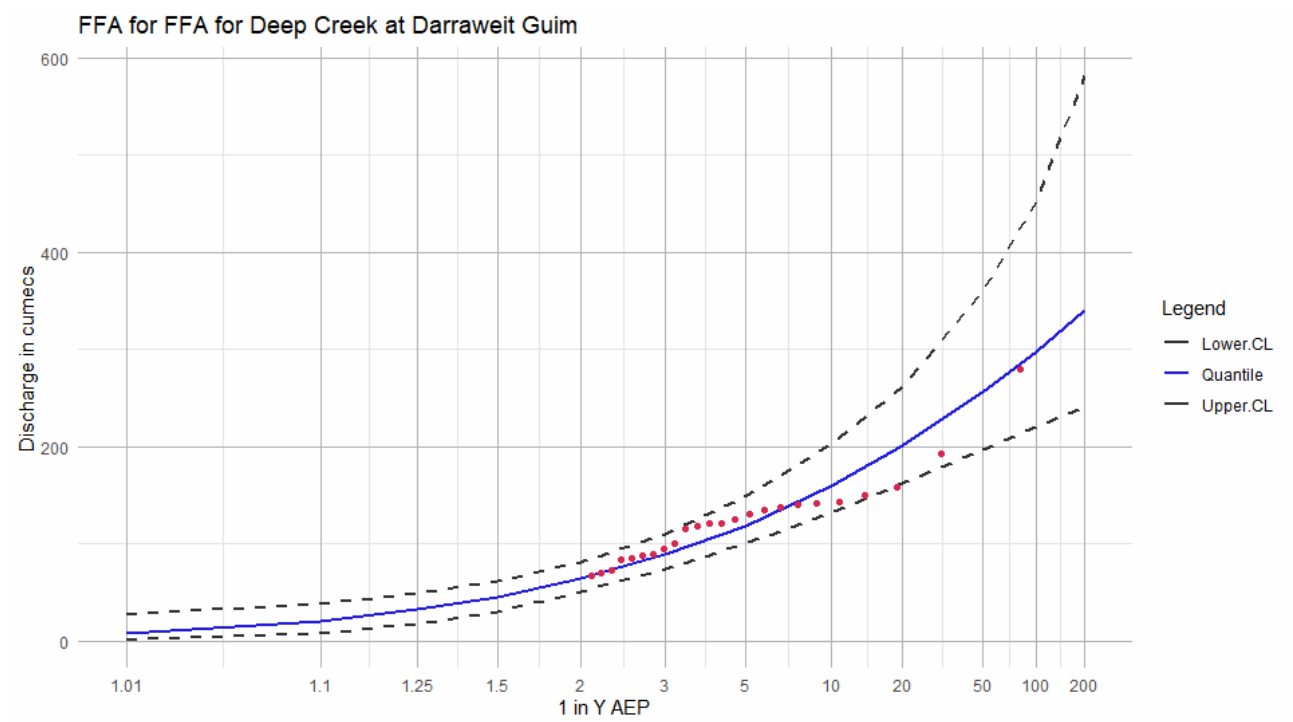
Figure 24: Deep Creek at Darraweit Guim FFA results

AEP	Expected Quantile (m ³ /s)	Lower 90% Quantile Confidence Limits (m ³ /s)	Upper 90% Quantile Confidence Limits (m ³ /s)
20%	120	101	148
10%	160	132	202
5%	200	162	261
2%	255	197	360
1%	300	221	452
0.5%	340	240	580

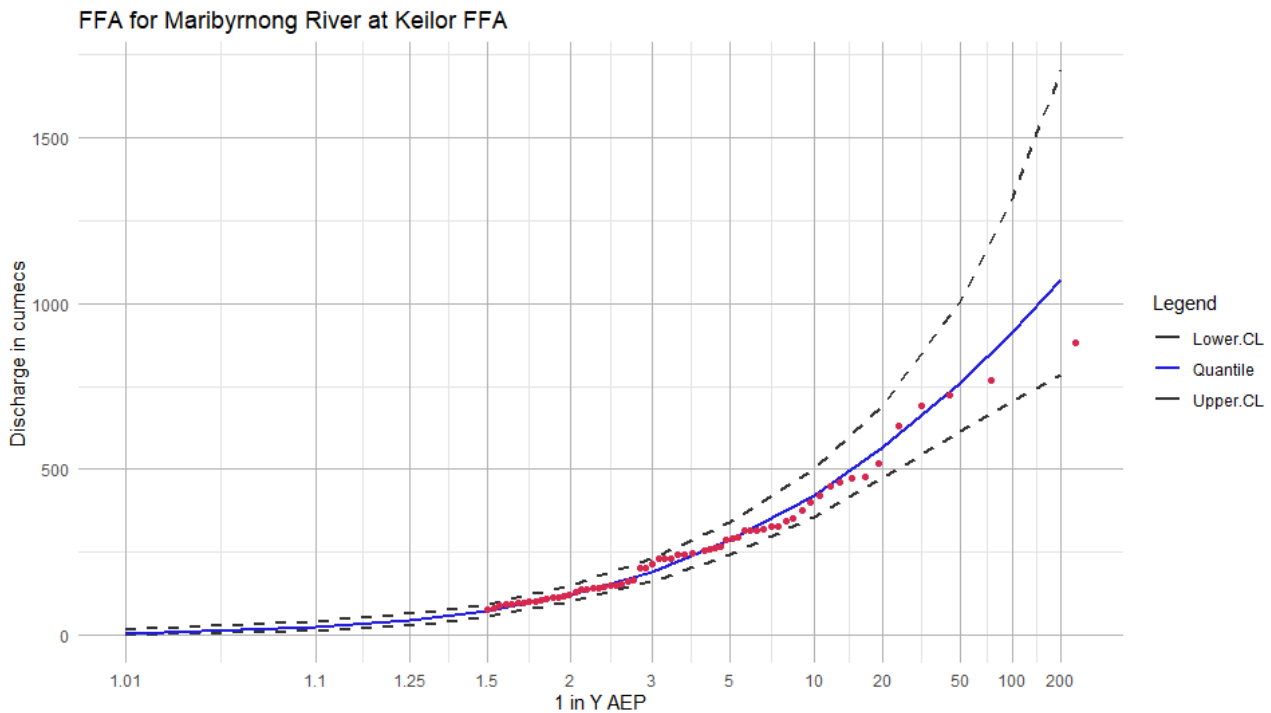
Figure 25: Maribyrnong River at Keilor FFA results

AEP	Expected Quantile (m ³ /s)	Lower 90% Quantile Confidence Limits (m ³ /s)	Upper 90% Quantile Confidence Limits (m ³ /s)
20%	285	240	340
10%	420	360	500
5%	565	470	690
2%	760	610	1005
1%	915	705	1320
0.5%	1070	785	1700
